Removal and Repair of Rhodes 22 Diamond Board on Lillipelli

John Carlson (john_carlson@mac.com)

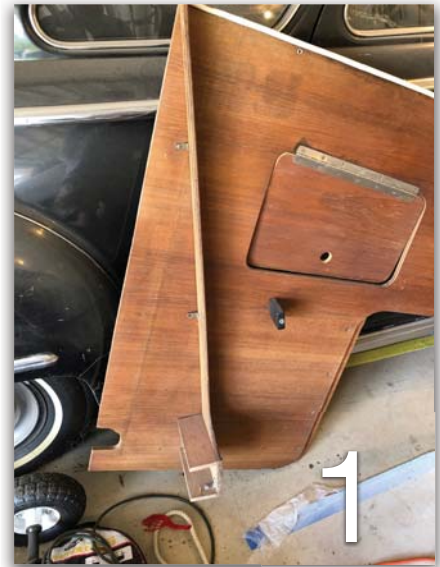
Helpfully, I didn’t photograph this process at all. I took out the large teak “U” that makes up most of the visible teak in the cabin. This wasn’t as hard as I expected, although maneuvering it out of the cabin and off the boat required some help. See it to the right after removal, resting in the garage (photo 1).

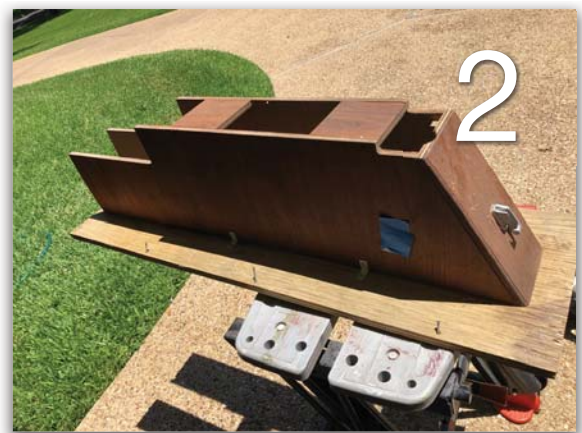
The last of the interior that had to come out was the box that surrounds the centerboard cap and supports the “U” where you step into the cabin. I left it connected to the part of the sole it was attached to and removed it as a unit. You can see it resting on a workhorse in my driveway (2). My grass looks good!

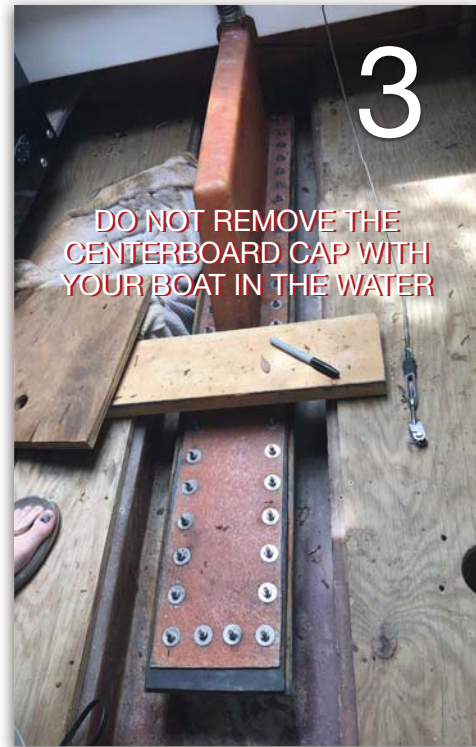
Maybe the first thing to know is that the centerboard is *heavy*. I was able to position two (purple) moving straps around it, but straining to lift it with my keyboard-sculpted physique did nothing. You can probably sense the surprise, disappointment, and stabbing back pain in photo 4.

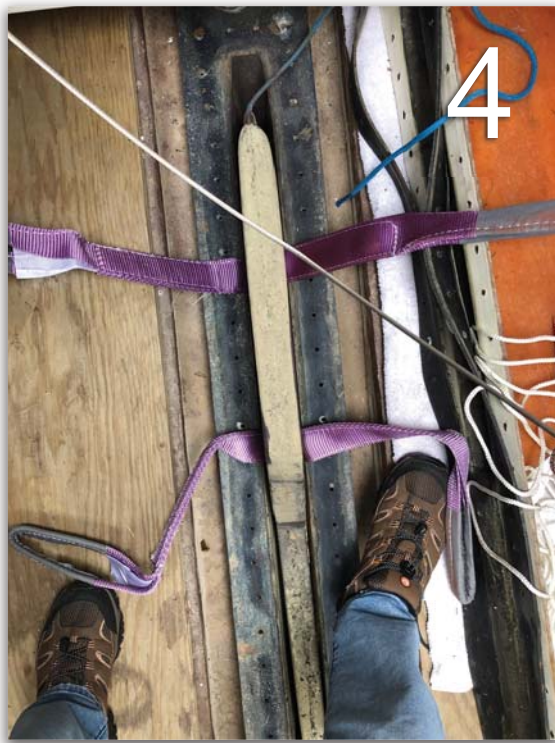
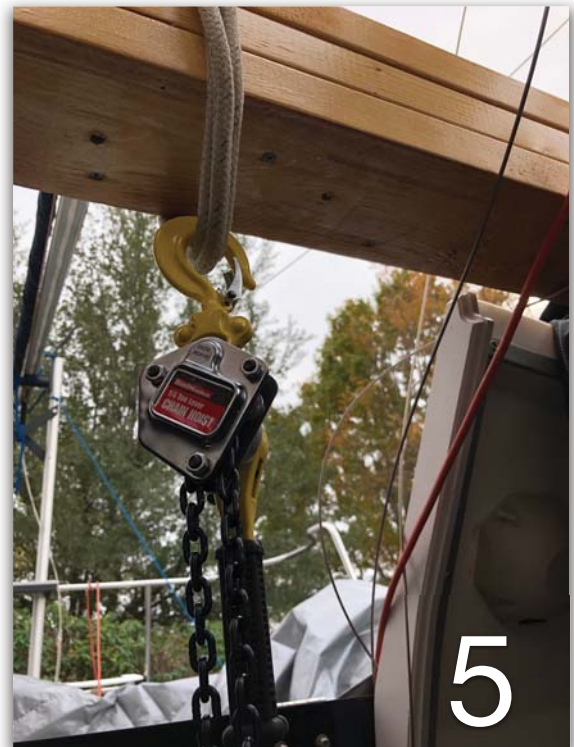
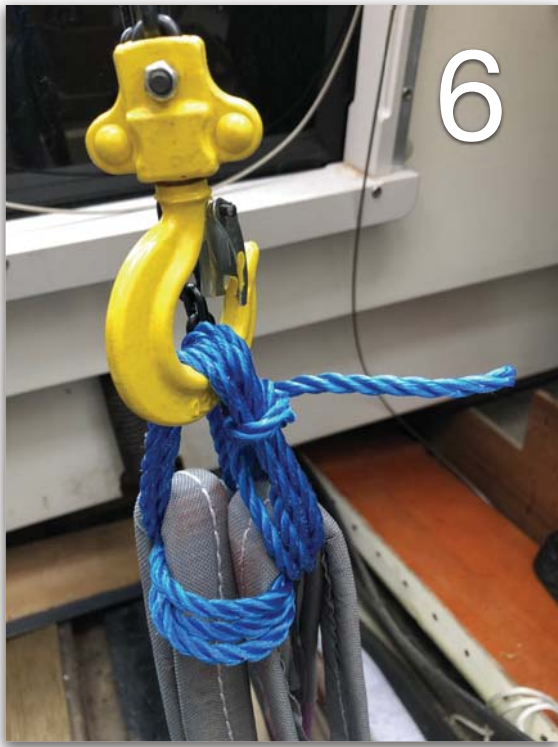
Back to Harbor Freight! I grabbed a chain hoist and used a laughably heavier-than-needed beam I made for something else to lift the centerboard (5-7).

The beam just rested on the cabin top, on top of towels to prevent any scuffing.

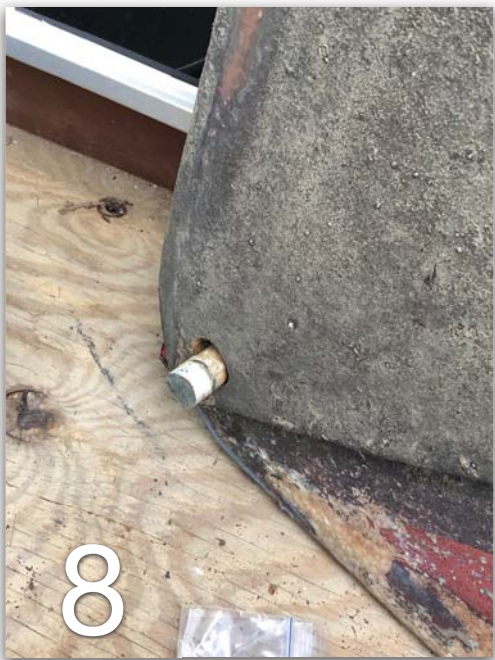
Once on the cabin sole, the pivot pin (8) drops right out and appears to be made from a resin of some sort. It seems a bit odd, but I guess it works. I worried that changing it to something better (like stainless steel) could wear on the slot it fits in the trunk over time.

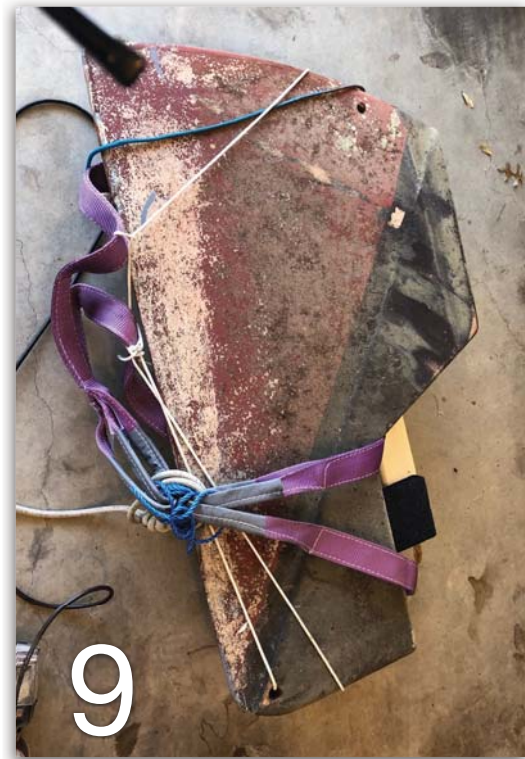
Once on my garage floor (9), I was able to assess the board. This was my first good look at a part of my boat that I'd owned for 7 years. It wasn't pretty, but there was no major damage, and I couldn't detect any voids or water intrusion.

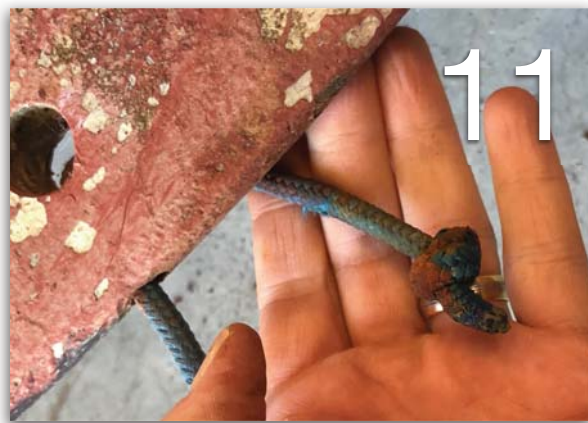
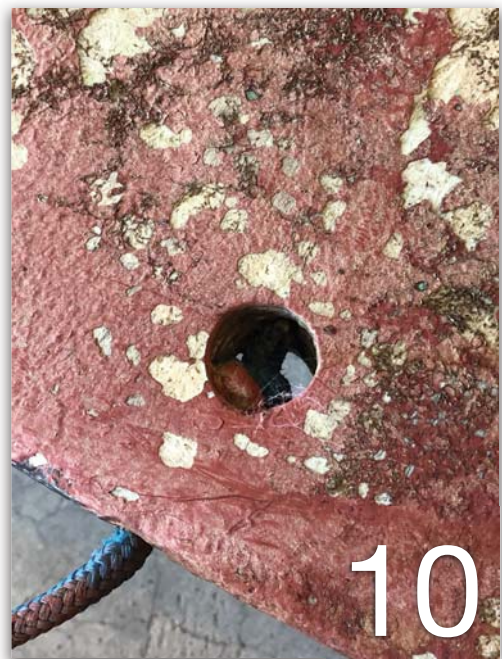
The pendant to lift the board is attached via a small hole at the rear of the board (10). It is simply knotted to keep it in place (11).

Given that I was going to replace the pendant anyway, and because my feeble fingers couldn't undo the knot, I cut the line to remove it.

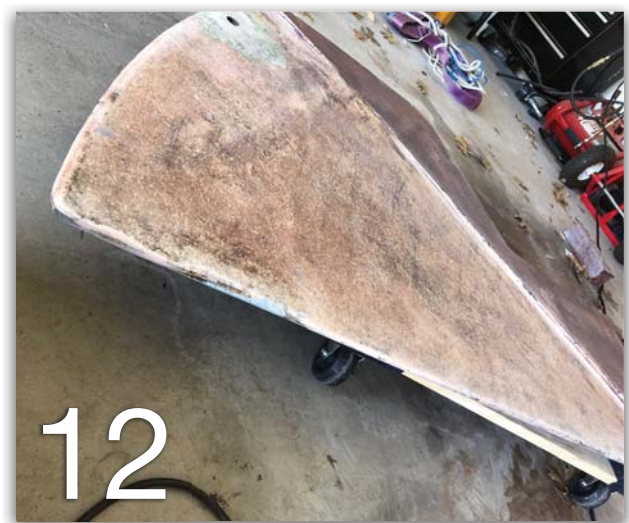
I sanded the board and faired it using epoxy. Small areas of damage were fixed either with thickened epoxy or Marinetex (12). I recall using Gluvit as well, mainly because I liked saying the name.

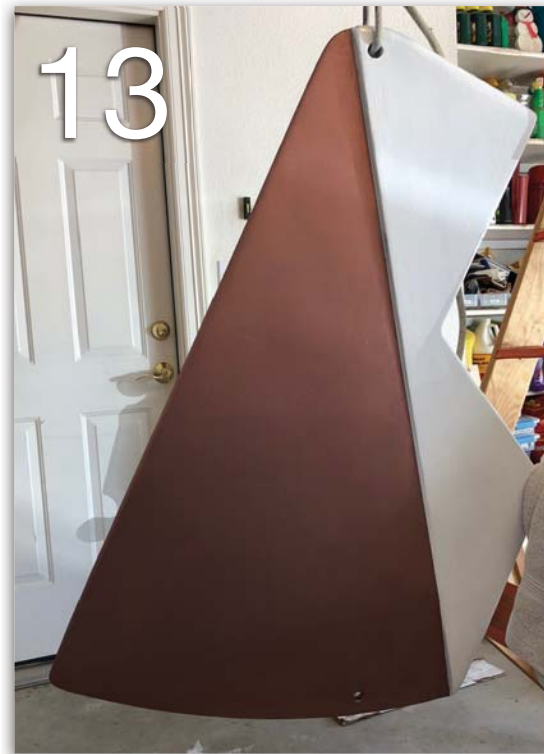
I repainted it using a copper-based anti-fouling paint (Sea Hawk?) and something white at the top. Not sure what I used now, but it looked good (13).

You might be able to tell, but the board is suspended via a section of 2x6" laid across the open attic hatch.

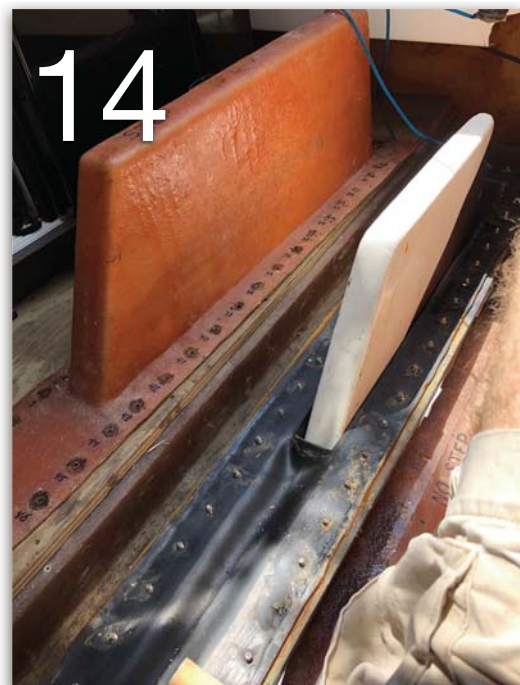
Once I collected myself, we carefully lowered the board back into it’s trunk (14) and I replaced the original gasket, which appeared to be in okay shape.

At this point, **make sure to run the pendant line up through the centerboard cap!** If you manage to bolt the cap on without doing this, you’ll have to take it back off.

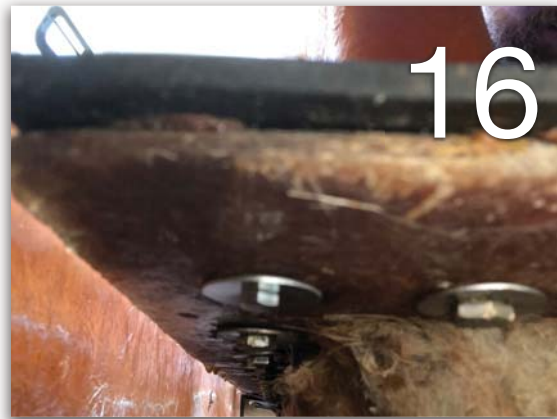
When replacing them, I switched the direction of the bolts so that the heads were now down. I found it easier to attach a wrench to the bottom while ratcheting the nut from the top (16).

Finding bolts that would fit through the holes was troublesome, and I ended up having to buy some extra stainless bolts to fit. Some of the holes didn't line up vertically, which added to the challenge. The amount of room that you have to

hold and maneuver tools under the flange is quite limited, and your access to the rear of the centerboard cap (i.e., toward the stern) is also restricted.

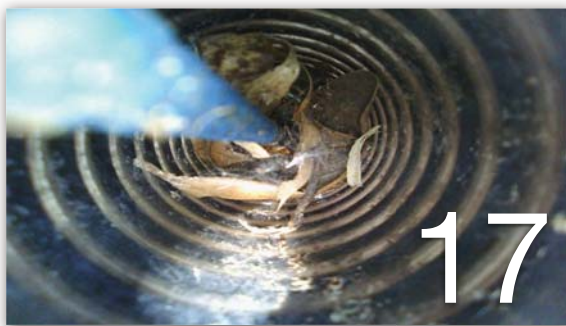
All humor aside, I received some great feedback and ideas. I bought a camera to allow me to peek down the pendant tube (17) and up the trunk from below (18). I had hoped to find something obvious, like a wasp nest, that was blocking the free movement of the board. I could see a bit of pendant from below, which was out of place. But there wasn't anything I could take action on. Well, I pointed the power washer down the pendant tube to blow out the debris, but that didn't help.

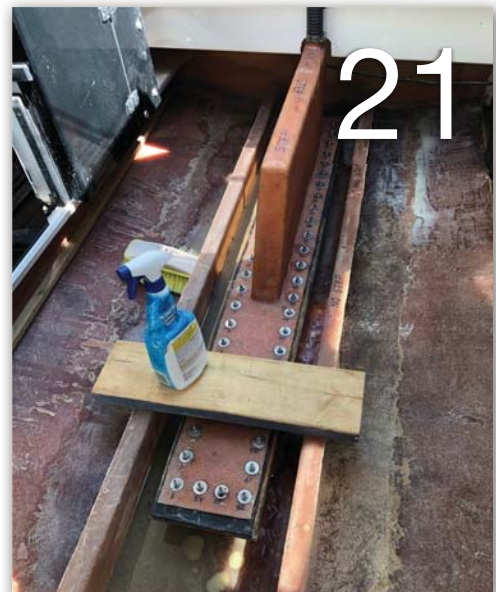
However, it was in somewhat poor shape. It badly needed sanding and a bit of fairing before being painted. So, I removed the rest of the sole and took it to the garage. I cleaned the bilges and realized they needed some attention as well. There were some large bubbles and areas where the mat wasn't affixed to the resin. So, they looked better after some cleaning, sanding, maybe some grinding, and epoxying (21-22). Oh, I definitely used more Gluvit as well!

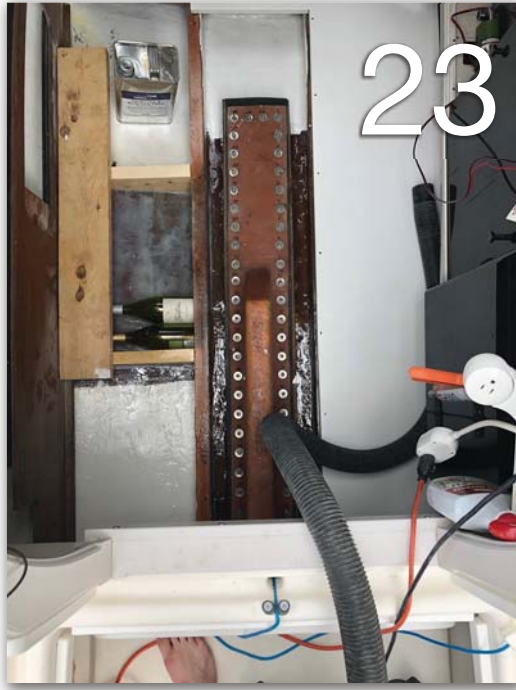
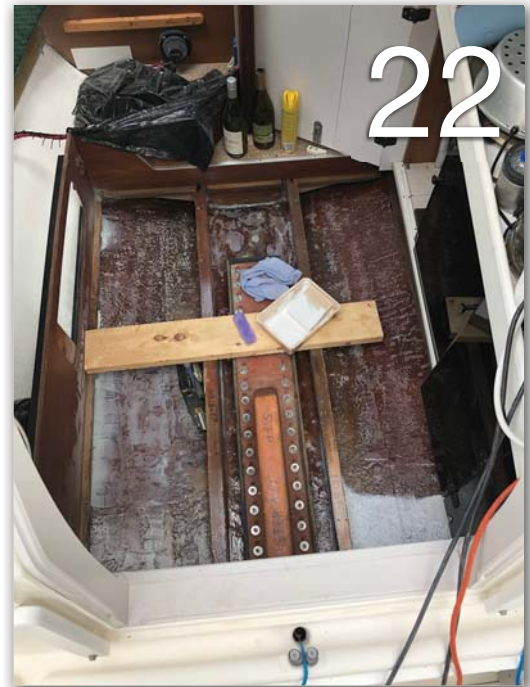
The end-goal was to have relatively smooth and painted surfaces under the sole and also under the bench (23). At some point, I realized that the shape of the bilge adjacent to the main centerboard trunk would easily fit several bottles of wine on their side (23). This epiphany led to

the addition of the *Rhodes Wine Cuddy*™ in the port side bilge. I made it fairly small and routed drainage around it, so I hope it won't cause any issues. If it does, at least I'll have the wine.
