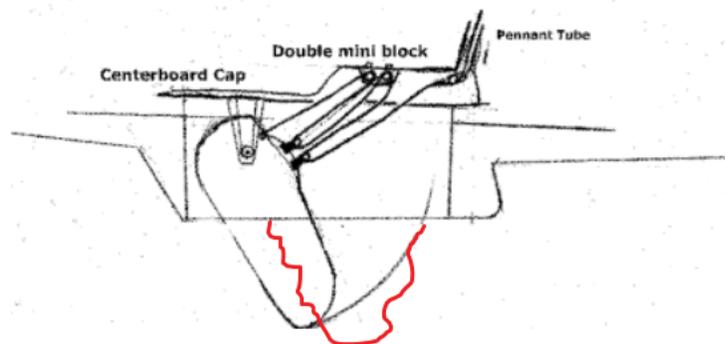
Cross Section of entire
Centerboard Mechanism

RED pennant line (approx. 2 feet) is hanging under boat

while CB is stuck in Keel.
